Manhole Inspection Summary

Manhole # S39YY_031MH

Insp Date: **12/14/06 12:16 PM**

Location Address: **802 GORSUCH AVE**

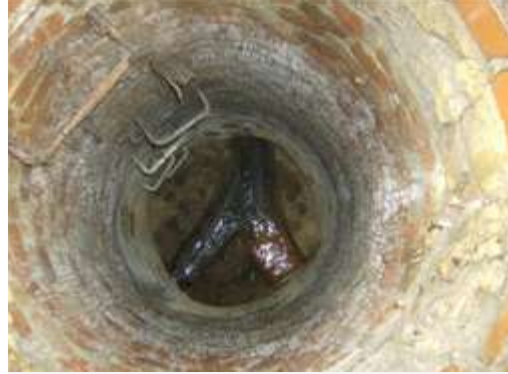
Top View

Barrel infiltration. Corroded and missing steps.

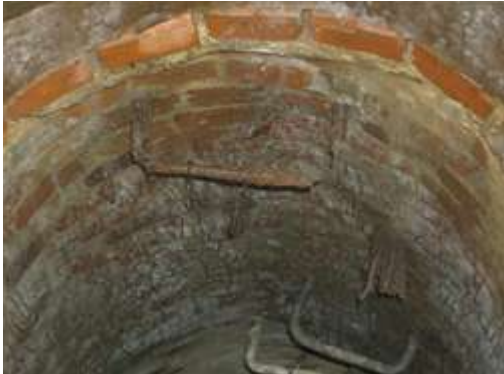
Defect

Frame leaks. Adjustment deterioration and infiltration. Corbel infiltration.

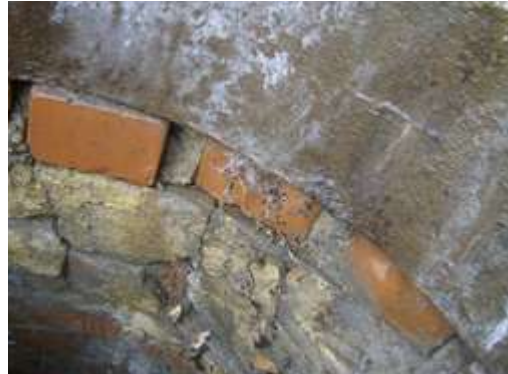
Defect

Frame leaks. Adjustment deterioration and infiltration.

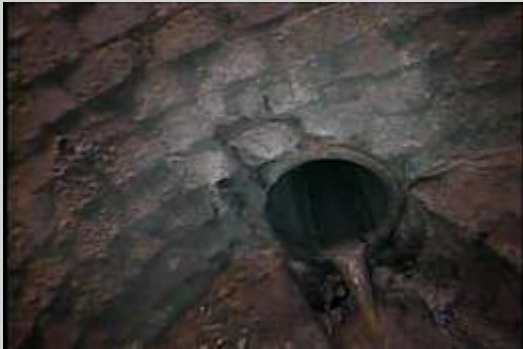
15 in. Circular Gravity Sewer Pipe Out @ 12 O'Clock

Invert Depth: **13.08** (ft.) Flow Characteristics: **Slow**

Infiltration: **None** Pipe Seal Cond: **Unknown**

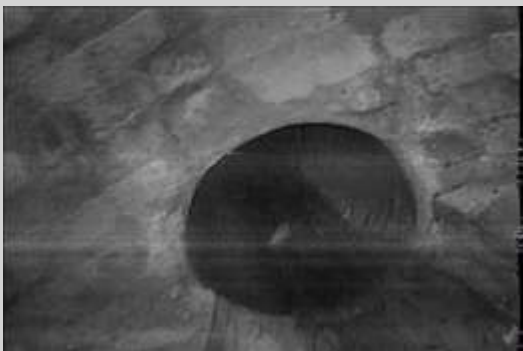
15 in. Circular Gravity Sewer Pipe In @ 5 O'Clock

Invert Depth: **12.93** (ft.) Flow Characteristics: **Slow**

Infiltration: **None** Pipe Seal Cond: **Unknown**

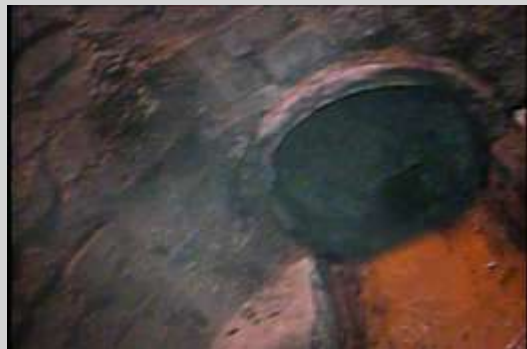
8 in. Circular Gravity Sewer

Invert Depth: **12.64** (ft.) Flow Characteristics: **Slow**

Infiltration: **None**
